#### NOTICE OF VIOLATION

Premium Shingle, LLC

Washington Industrial Stormwater General Permit Number WAR302620

# NPDES Inspection Report

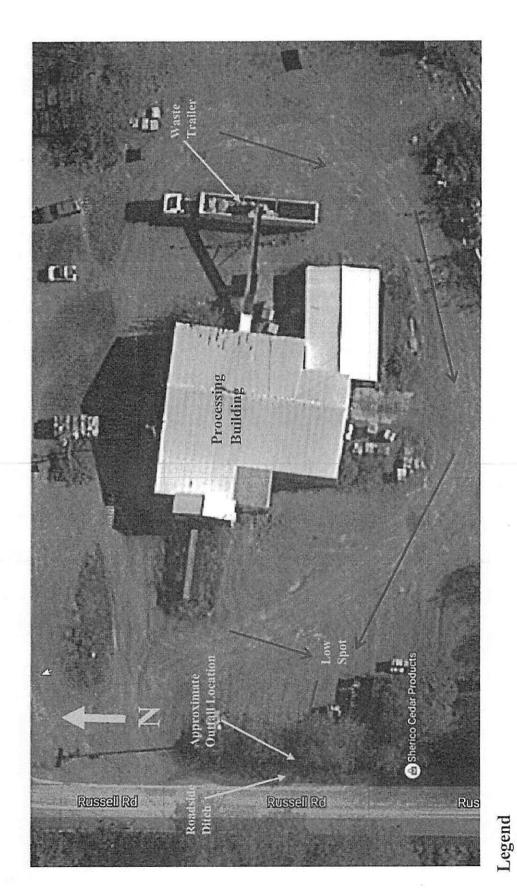
# Aerial Photograph

Observations during the facility tour portion of the inspection indicate that the topography of the site is such that the bulk of the stormwater generally infiltrates into the ground or flows toward the southwest corner of the property. Stormwater accumulated at the southwest corner of this site is then ultimately routed to Mill Creek. See the "Stormwater Generation, Treatment and Discharge" section of this report for further details on the discharges from this facility.

Identifies the stormwater flow pathway.

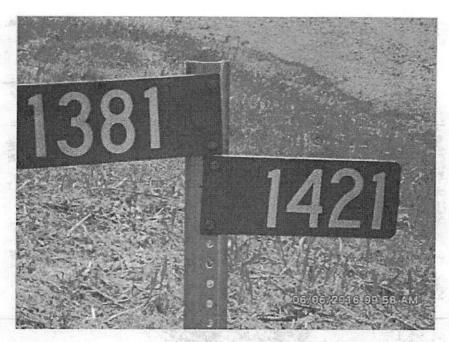
Photo #1: View of the roadside sign along Russell Road. The lot with address 1421 is the location of Premium Shingle, LLC and 1381is the location of the neighboring property owned by Rainy Day Shake and Shingle, Inc. Camera photograph #SAM 2383.

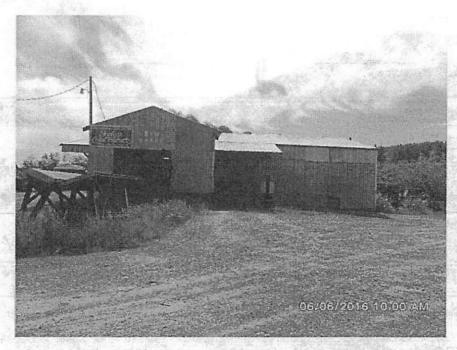
Photo #2: Easterly view showing the front (west side) of the processing building at the facility. Photographer is standing along Russell Road. Camera photograph #SAM 2385.

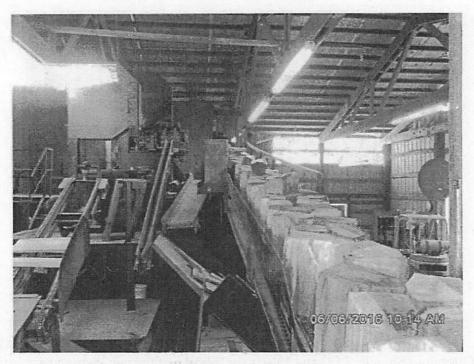
Photo #3: View inside the processing building of the cedar blocks being routed to the saws to manufacture shingles. Camera photograph #SAM 2397.

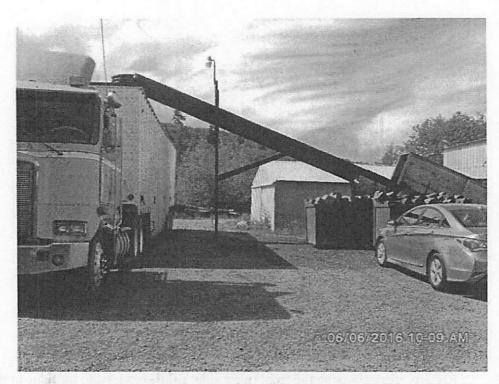
Photo #4: Southerly view along the east side of the processing building. Note the conveyor used to move wood waste from the building to the trailer. Camera photograph #SAM 2393.

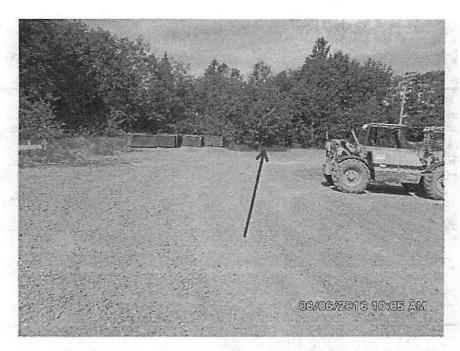
Photo #5: Westerly view of the drainage pathway to outfall 001. This is a view along the south side of the processing building. Note the empty wood bins in the background. Camera photograph #SAM 2388.

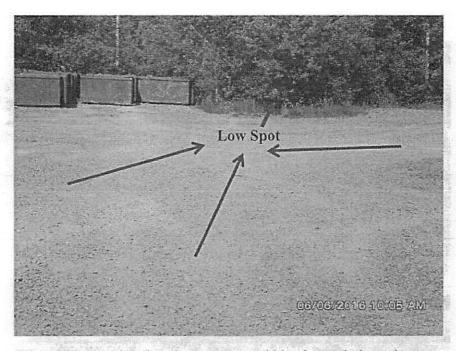
Photo #6: Westerly view showing the empty wood bins located along the western property boundary. The facility sampling location is located just to the right of these wood bins. The area to the right of the wood bins is the low spot on the property where stormwater accumulates before flowing off the property. Camera photograph #SAM 2386.

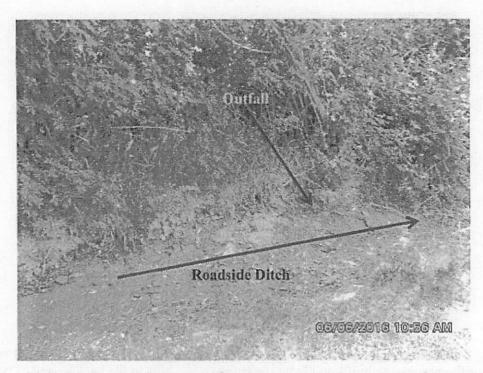
Photo #7: View in the vicinity of the outfall location. Note the roadside ditch in the foreground (along Russell Road) which receives this discharge. Camera photograph #SAM 2398.

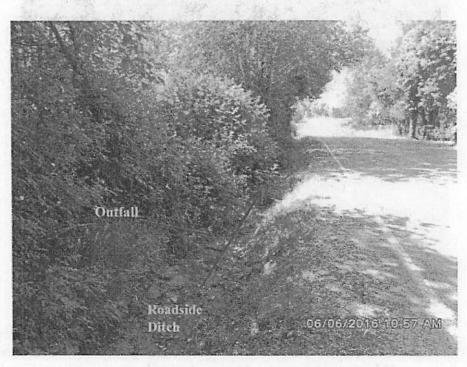
Photo #8: Southerly view showing the roadside ditch along Russell Road. Camera photograph #SAM 2399.
